Evaluation Report

Great Northern Model 902 CE Field Sprayer

ALBERTA
FARM
MACHINERY
RESEARCH
CENTRE

PRAIRIE AGRICULTURAL MACHINERY INSTITUTE

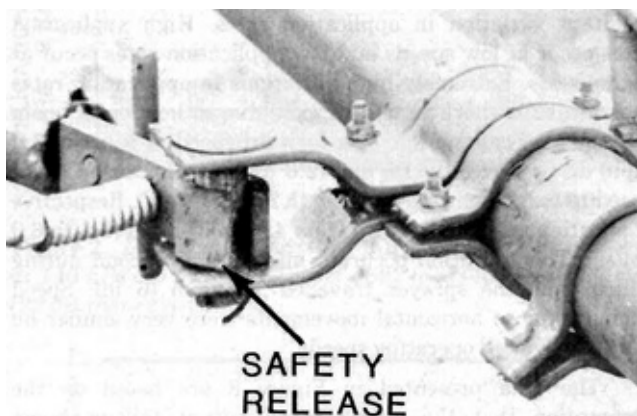
Figure 9. Safety Release on Radius Arm.

Radius Arm: The value of the safety release on the boom radius arms was questionable (Figure 9). Operation on rough fields caused the safety clamp to release. Operators then would over-tighten the clamp so that it would not release. This rendered the safety release ineffective.

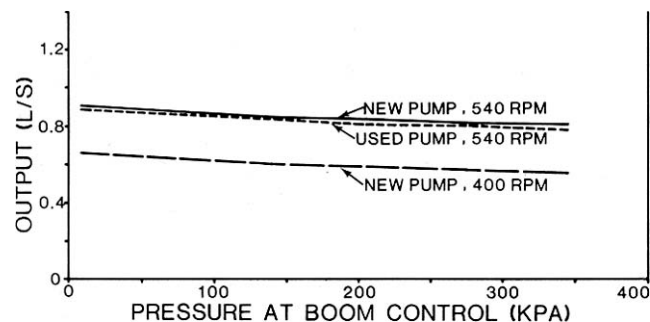
Figure 11. Pump Curves.

Agitation Capability: The Hypro 7700 pump, supplied as standard equipment, has a delivery, when new, of 0.82 L/s (10.8 gal/min) at 275 kPa (40 psi) and 540 rpm (Figure 11). This was adequate to apply 92 l/ha (8.2 gal/ac) of emulsifiable

concentrates at 8 km/h (5 mph) but there was not sufficient pump capacity to apply wettable powders and provide sufficient agitation to keep the solution in the tank properly mixed. The larger Hypro 1700 pump, available as optional equipment, should be obtained if wettable powders are to be applied. Normally recommended agitation rates for emulsifiable concentrates such as 2,4-D are 0.03 L/s per 100 L of tank capacity (1.5 gal/min per 100 gal of tank capacity). For wettable powders such as Atrazine and Sevin, recommended agitation rates are 0.05 L/s per 100 L of tank capacity (3.0 gal/min per 100 gal of tank capacity).

Operation at Reduced Speed: Figure 11 also shows that reducing pump speed from 540 rpm to 400 rpm resulted in a 30% reduction in pump output. Reduction in pump speed would occur when reducing tractor speed to turn a corner or when operating at reduced engine speed to obtain a correct ground speed to suit nozzle calibration.

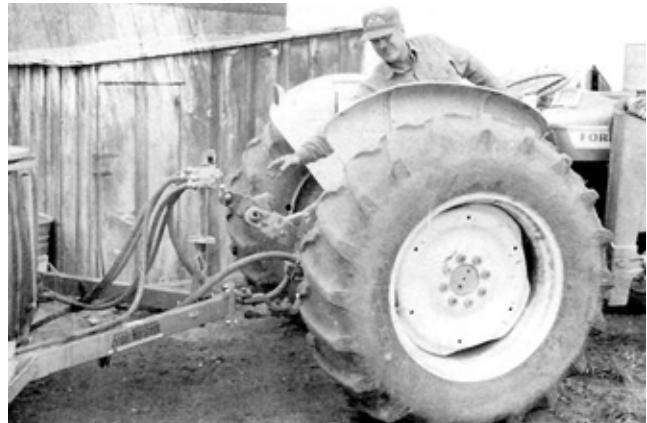
Figure 12. Awkward Location of Controls.

Controls: Chemical flow to the booms was controlled with one lever. The pressure gauge could be read from the tractor seat of most tractors. However, the controls were impossible to reach from this position (Figure 12). Application rate was controlled by adjusting tractor ground speed and spraying pressure. Pressure was controlled with the pressure regulator, the agitator control valve or a combination of the two (Figure 13). The pressure regulator was sensitive to adjust since small adjustments resulted in a large change in pressure. Modifications are required to make pressure less sensitive to adjust.

6. Modifications to make pressure adjustments less sensitive.
7. Modifications so that controls can be reached from most tractor seats.
8. Modifications to prevent leakage at the boom extensions.

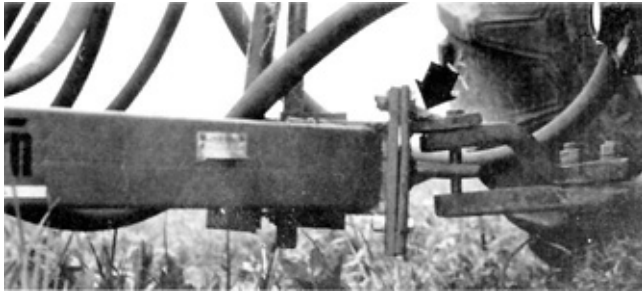
Figure 20. Bent Hitch Clevis.

- the hitch clevis bent at	35	682	(1686)
- the rocker axles were worn at	end of test	974	(2408)
BOOM AND CASTOR FRAME			
- the front castor wheel frames were bent at	40	779	(1926)

Hitch Clevis: The hitch clevis bent in the field (Figure 20). Although the hitch did not fail completely, modifications are required to prevent bending.

9. Modifications to reduce whip at the centre of the boom sections.
10. Modifications to eliminate hitch clevis deformation.
11. Modifications so that the rocker arm grease fittings accept grease.

8. Modifications to prevent leakage of the fittings have been made.
9. This recommendation is being taken under consideration.
10. The hitch has been strengthened on 1977 models.

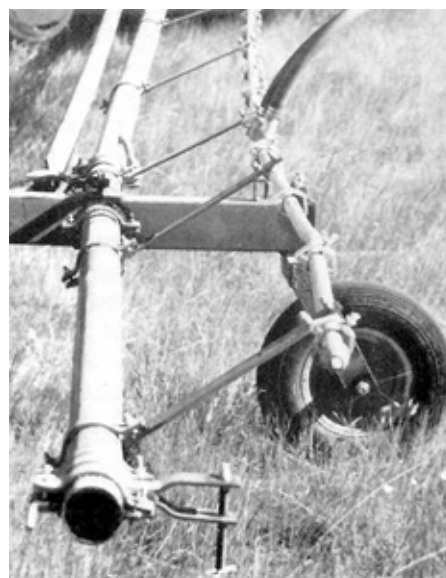
Figure 25. Bent Boom Carrier.

- three of the boom struts were bent at	43	838	(2071)
- the left boom carrier was bent at	46	896	(2215)
